IDAS™ Technical Tips

**Typical causes and solutions for:
Registration and handshaking process failure
in an IDAS Multi-site Trunked System**

**IC-F3160/F3260 Series Handheld Radio
and
IC-F5060 Series Mobile Radio**

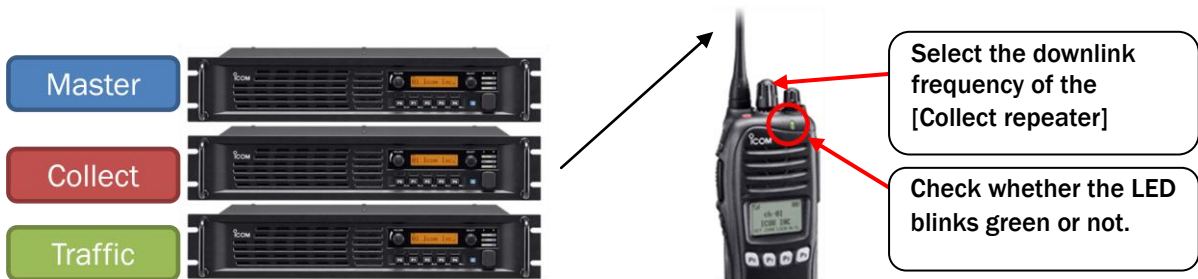
1-1-1 Signal strength

Possible cause: The [Site ID] from the [Collect repeater] does not reach the radio.

How to verify: Using a test radio, select the downlink frequency of the [Collect repeater] and wait at least 6 seconds. If you are at a location where the [Site ID] can be received, you can hear the digital modulation every 5 seconds. Press the [User Set Mode] key and select “System Info”. Then you can check the signal strength of the [Site ID] and judge whether the repeater downlink is strong enough.

- Install a higher gain antenna at the repeater site
- Increase the output power at the repeater site
- Add a repeater site closer to the radios.

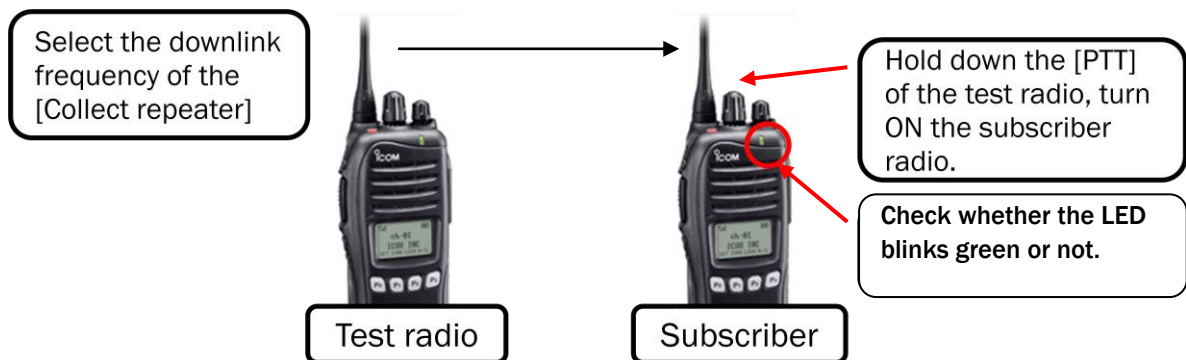
1-1-2 Frequency setting

Possible cause: The [Collect repeater] frequency input into the radio is incorrect.

How to verify: Using a test radio, select the downlink frequency of the [Collect repeater], and hold down [PTT]. Then turn ON the subscriber radio and wait at least 6 seconds, see if the LED blinks green or not. If the frequency setting is incorrect, the LED of the subscriber radio does not blink green.

Solution: Read* the frequency from the radio. Input the correct TX/RX frequencies for the [Collect repeater], if necessary.

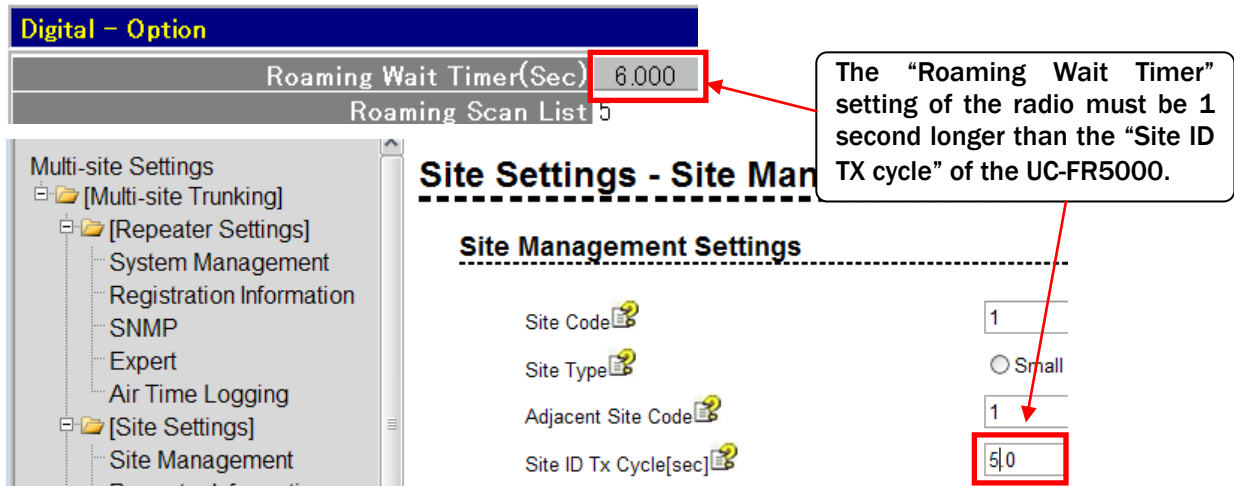
1-1-3 Roaming Wait Timer

Possible cause: The “Roaming Wait Timer” setting may be too short, and the radio starts scanning before it receives the [Site ID] from the [Collect repeater].

How to verify: Read* the “Roaming Wait Timer” setting of the radio, and compare it with “Site ID Tx Cycle” in the browser setting menu of the UC-FR5000.

Solution: Set the “Roaming Wait Timer” of the radio for 1 second longer than the “Site ID Tx Cycle” of the UC-FR5000 so that the radio has enough time to receive the [Site ID].

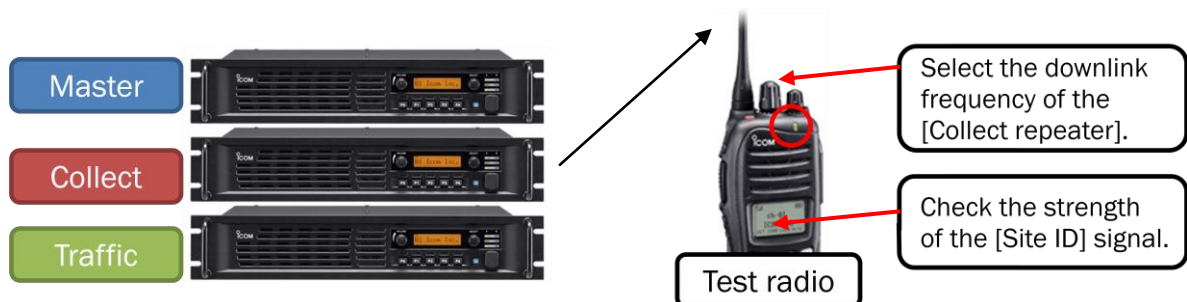
1-2-1 “Roaming Level”

Possible cause: The “Roaming Level” of the radio is set too high so the radio ignores the [Site ID] received from the [Collect repeater]. For example, if “Roaming Level” is set to -100dBm, then the radio will ignore all [Site ID] with a level of -101dBm or weaker.

How to verify: Using a test radio, input the downlink frequency of the [Collect repeater], and wait at least 6 seconds to receive the [Site ID]. Enter “User Set Mode” and select “System Info” to see the signal strength of the [Site ID].

Solution: Try the default setting of -114dBm at first, then adjust the “Roaming Level” value if necessary.

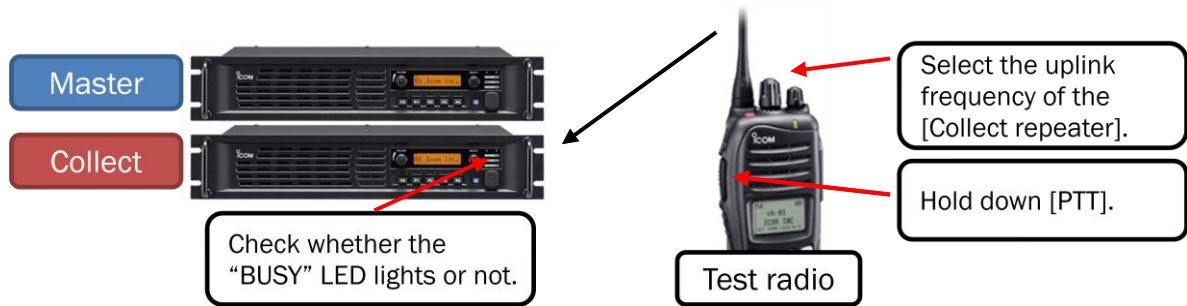
1-3 The TX/RX LED blinks red and green

Possible cause: The connection request from the radio may be too weak to reach the [Collect repeater], due to the distance between them.

How to verify: Using a test radio, select the uplink frequency of the [Collect repeater] and hold down [PTT]. Check if the “BUSY” LED of the [Collect repeater] lights green while the test radio is transmitting.
Assign the [User Set Mode] feature to a desired key, enter “User Set Mode”, then you can check the signal strength.

- Switch to the “High” output power setting of the radio.
- Install a higher gain antenna at the repeater site.
- Add an RX preamplifier to increase the receive sensitivity.

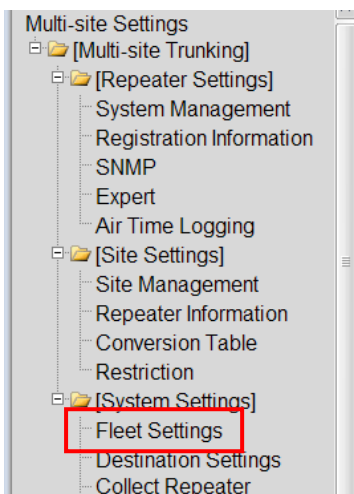
1-3-1 Fleet setting

Possible cause: The radio ID is not registered to the system as a member of a Fleet. In this case, the connection request from the radio reaches the [Collect repeater], but the [Collect repeater] judges it as invalid.

How to verify: Check the “Prefix” and “Unit ID” setting of the radio. Open the UC-FR5000 browser setting menu of the System Master repeater, and see whether the “Prefix” and “Unit ID” of the radio are registered as a member of any Fleet.

Solution: Register the radio ID to the system as a member of a Fleet.

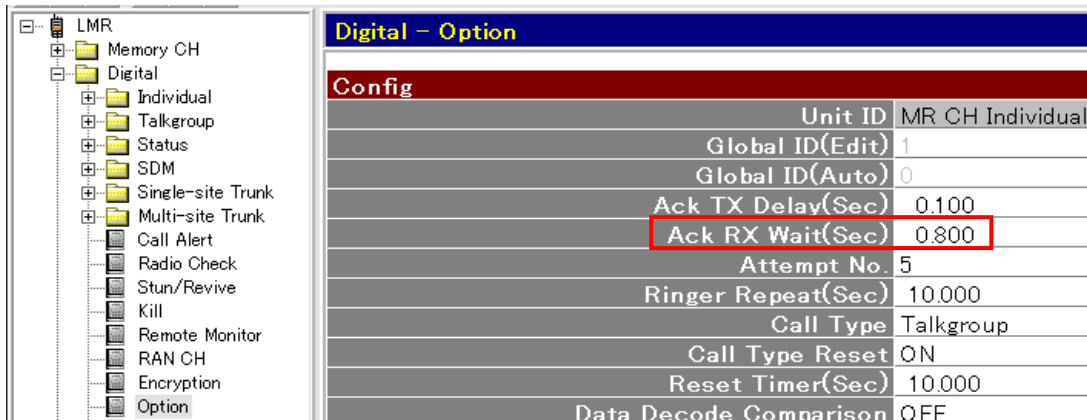
2-1-1 Ack RX Wait (Sec)

Possible cause: The “Ack RX Wait” timer of the radio is set too short and therefore the radio does not receive the acknowledgement sent back from the [Home repeater].

Solution: Adjust the value of “Ack RX Wait” timer in the radio. The recommended value be set is 2.6 seconds in the Multi-site Trunked mode.

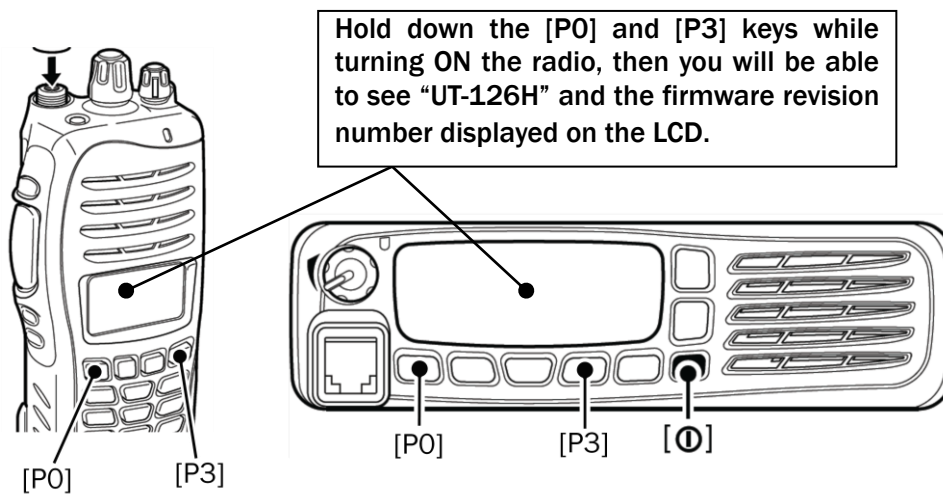
3-1 The LCD display of the radio blinks

The radio does not function properly even if you press any programmable key or [PTT], or even if you turn the radio OFF and then ON again.

Possible cause: The UT-126H digital unit does not work properly due to a data error.

How to verify: Hold down the [P0] and [P3] keys while turning ON the radio; "UT-126H" and the firmware revision number will be displayed on the LCD. If the displayed unit name is different than "UT-126H", then the UT-126H does not work correctly and must be replaced.

Solution: Open up the radio, and replace the UT-126H with a new one.
